SEM-XRD investigation of deterioration morphologies and consolidation prior to restoration: the case of Porta Nuova in Ravenna (Italy)

Key Words: *Deterioration, SEM-EDS and XRD, consolidation and securing, Porta Nuova.*

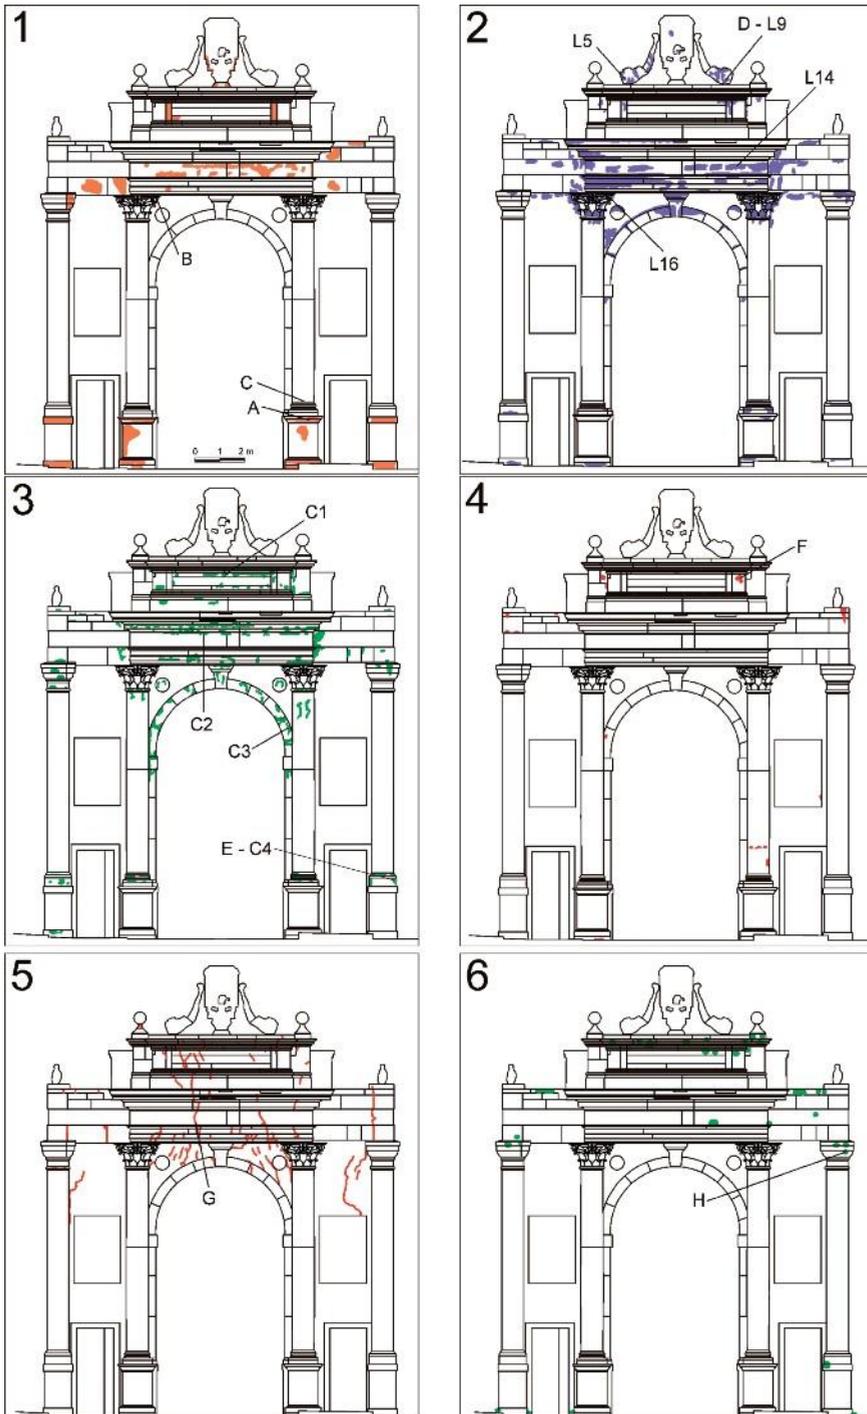
one of the materials that suffered major deterioration is the rosso ammonitico Veronese limestone, which shows diffuse detachment of nodular portions. this kind of deterioration is less evident on vertical surfaces, whereas it is particularly enhanced on the projecting and finely finished elements (Fig. 2-1-a and Fig. 3-

a). the nodular structure represents an intrinsic property of this limestone and the presence of matrix between the nodules has favoured the detachment as a consequence of stress caused by cycles of freezing and thawing of interstitial water and sudden temperature changes. the nodular and inter-nodular portions present a different degree of compactness and cementation. therefore humidity and chemical and biological agents while favouring the detachment of the first, easily crumble the latter. Differential deterioration is particularly enhanced also on Marmor proconnesium above all on ashlar corners and on capitals, where the surficial decohesion with detachment of calcite crystals is associated to fractures penetrating the marble. the surface decay and erosion can also be appreciated on limestone “vacuolar” (Fig. 2-2-D and Fig. 3-D) where we assist to consumption of the cornucopias fruits.

exfoliation is particularly enhanced on the Marmor troadense columns (Fig. 2-1-c and Fig. 3-c), with formation of surface sub-parallel flakes, often followed by detachment of the exterior part and consequent reduction of the column diameter. the single fragments (flakes) show a series of inter- and intra-granular fractures. this kind of deterioration can be ascribed to different causes, among which thermal shocks (particularly in the sun exposed zones) and the rock processing (all the ornamental stones were carved perpendicularly to the surface, which favours the following detachment of flakes, cf. Iazzarini, 1987). contour scaling can be also observed at the base of the Marmor troadense columns. here, maximum humidity and static load occur where the columns lean on the stylobate.

another major deterioration morphology reported for porta nuova is the formation of cm-thick black crusts that cover the material surfaces and are mostly developed on the undercut surfaces protected by washing away rain (Fig. 3-B and Fig. 3-D).

Fig. 2 (front page) - schematic sketch of porta nuova front with the distribution of the main deterioration morphologies. 1- Differential deterioration. 2- Black crusts. 3- Oxalate films. 4- rust spots. 5- Fracture systems. 6- Biological patina and vegetation. a, B, c, D, e, F, G, h location of the macrophotographs of figure 3. c1, c2, c3, c4 location of the specimens of ca oxalates analyzed by XrD, figure 6. 19, 114 location of the specimens of black crusts analyzed in XrD, figure 5. 15, 114, 116 location of the specimens of black crusts analyzed by seM-eDs microscopy, figure 4.

cramps, clamps and iron nails fixed by molten lead have often been employed. The oxidation of these elements has brought to the formation of iron oxides with consequent volume increase. Main consequences are stone fractures around swelled metallic elements and disfiguring rust spots often percolating below the rusty iron (Fig. 2-4 and Fig. 3-F).

XIX century. The walls demolition, in the first half of the XX century, caused a loss of lateral supports. Vibrations and shocks produced by the movement of heavy goods vehicles, brought to fracturation of the main supporting elements of the Gate. The fracture system (Fig. 2-5 e Fig. 3-G) in turn led to a progressive subsidence and bending of both the arch and the architrave, yet overloaded by the overlying attic.

on porta nuova stones has not been reported the occurrence of lyophilic lichens. Their disappearance has likely to be related to the air quality that in the historic centre of Ravenna is particularly polluted. The mapped weeds are represented almost exclusively by parietaria officinalis L., whose roots grow within the joints of ashlar stones. The presence of the fern asplenium trichomanes (Fig. 2-6 and Fig. 3-h) has also been detected. Green algae and moss have been observed in humid areas.

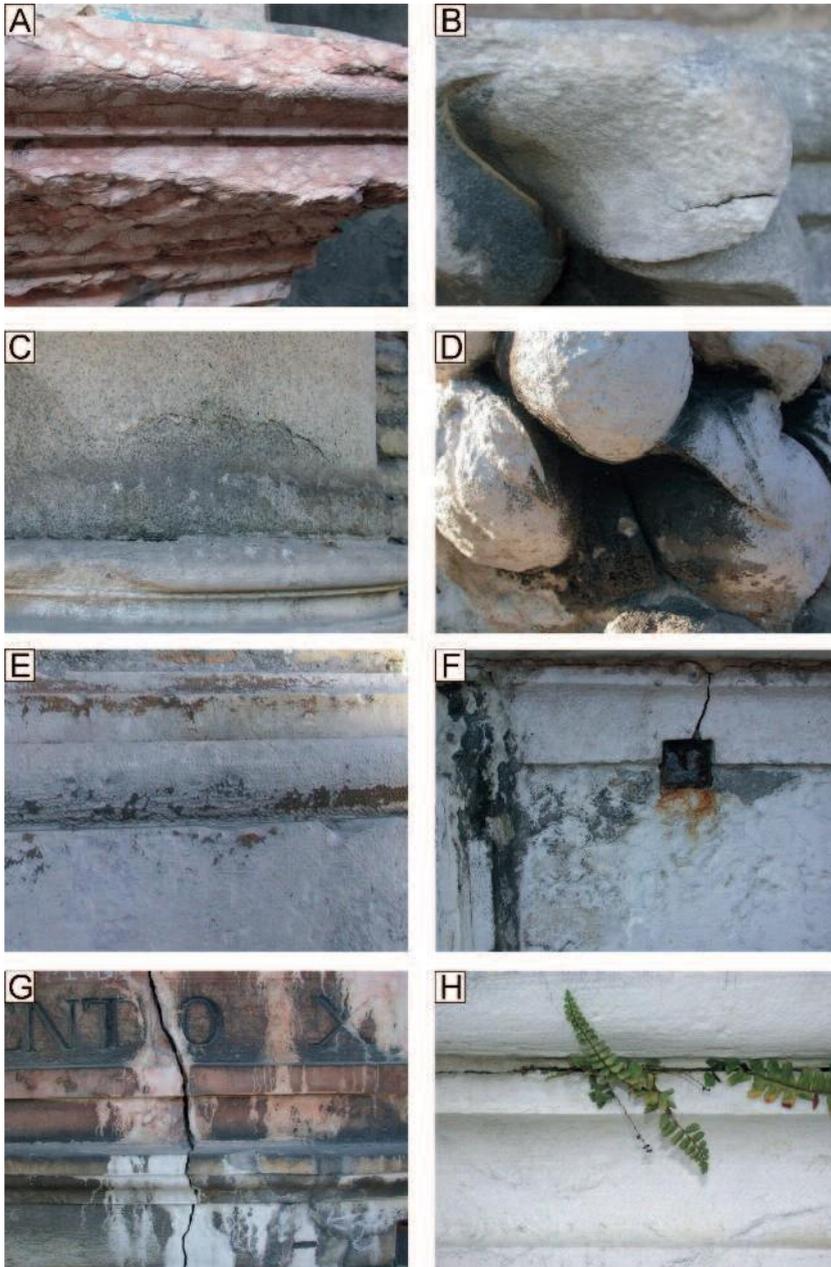
Fig. 3 - Macrophotographs of the main deterioration morphologies. Differential deterioration of rosso ammonitico Veronese (a), *Marmor Proconnesium* (B), *Marmor Troadense* (c), limestone “vacuolar” (D). Black crusts *Marmor Proconnesium* (B), limestone “vacuolar” (D). Oxalate films, limestone “facies liburnica” (e). Rust spots between pietra d’istria-Orsera and limestone “nodular” (F). Fracture systems along the rosso ammonitico Veronese and the pietra d’istria-Orsera (G). Vegetation (fern *Asplenium trichomanes*) between two elements of the limestone “facies liburnica” (h).

orsera and limestone “facies liburnica” (e). some patina also occur in the higher part of the granite columns below the marble capitals. We noticed that black crusts cover most of the patinas. in order to assess the composition of the patinas, we performed Xrd analyses reported in Figure 6. the patinas have been gently scraped from the stone surface trying to avoid the detachment of the black crusts and of the host material. samples c1 and c3 come from the surface of the pietra d’istria-orsera, sample c2 from the surface of the rosso ammonitico Veronese and sample c4 from the surface of limestone “facies liburnica”. We observe that in

our results present a proposition of conservation treatments that are in agreement with recent works (Lazzarini *et al.*, 2007) and can be extended to other case studies. First of all, conservation treatments need preliminary laboratory analyses to find out the best materials for the type of stones used in the monuments. Then deteriorated stones should be in principle structurally consolidated with ethyl silicate, which can glue the loose particles and thin sheets of powdering and flaking stones. Where heavy flaking occurs, epoxy resins should be used to bridge together two parts of a flake. all these

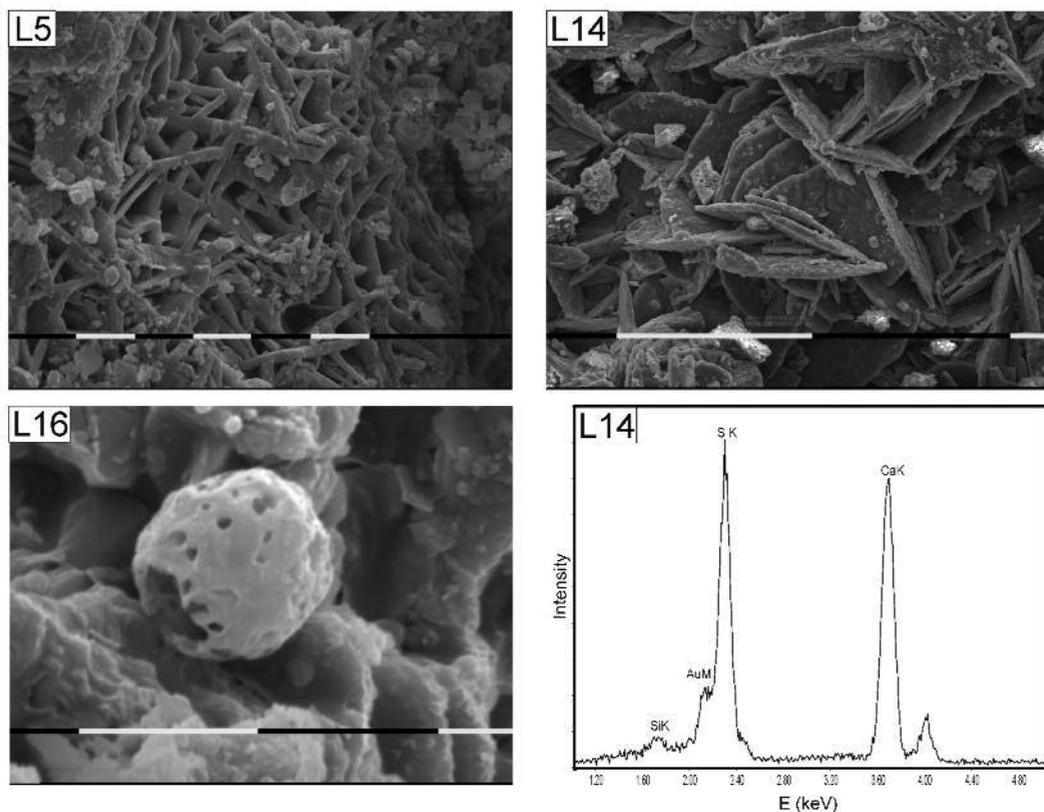
Black crusts have also been investigated by seM-eDs. Figure 4 reports Bse images of black crusts from the surface of the limestone “vacuolar” 15, rosso ammonitico Veronese 114 and Marmor proconnesium 116. they are formed by an association of lamellar gypsum crystals perpendicular to the supporting surface. in the interstices between crystals are entrapped carbon particles, quartz-feldspar grains and pollen. spherical empty particles of silica-alumina composition also occur (Fig. 4-116), these being related to combustion processes in industrial plants (Del Monte & sabbioni, 1983). the compositional spectrum of the black crust 114 shows that main components of gypsum (s and ca) plus minor si.

Fig. 4 - seM-eDs images of black crusts developed on the surface of the limestone “vacuolar” **15**, rosso ammonitico Veronese **114** and *Marmor Proconnesium* **116**. Length of bar is 0.1 mm for the images **15** and **114** and 10 µm for the image **116**. compositional spectrum of the black crust **114**. au peak derives from sample coating.

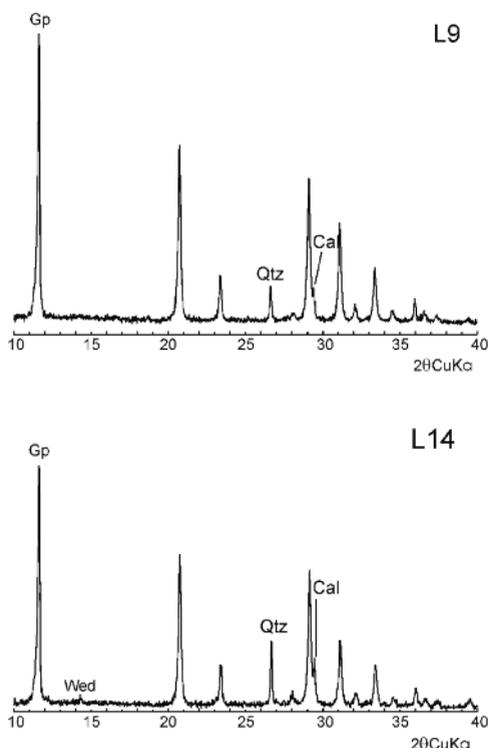
XrD investigation has been carried out on black crusts detached by the cornucopias fruits carved in limestone “vacuolar” (Fig. 2-2-19) and from the rosso ammonitico Veronese slab (Fig. 2-2-114). the analysis of XrD spectra (Fig. 5) has revealed the presence for sample 19 of abundant gypsum associated to minor calcite and quartz and for sample 114 of abundant gypsum associated to calcite, quartz and traces of weddellite (bihydrated calcium oxalate).

Fig. 5 - XRD patterns of the black crusts developed on the surface of limestone “vacuolar” **L9** and of the rosso ammonitico Veronese **L14**. The main peaks corresponding to the identified minerals were labelled as follows. Gp: Gypsum; cal: calcite; Qtz: Quartz; Wed: Weddellite. Mineral abbreviations are after Kretz (1983) except Weddellite.

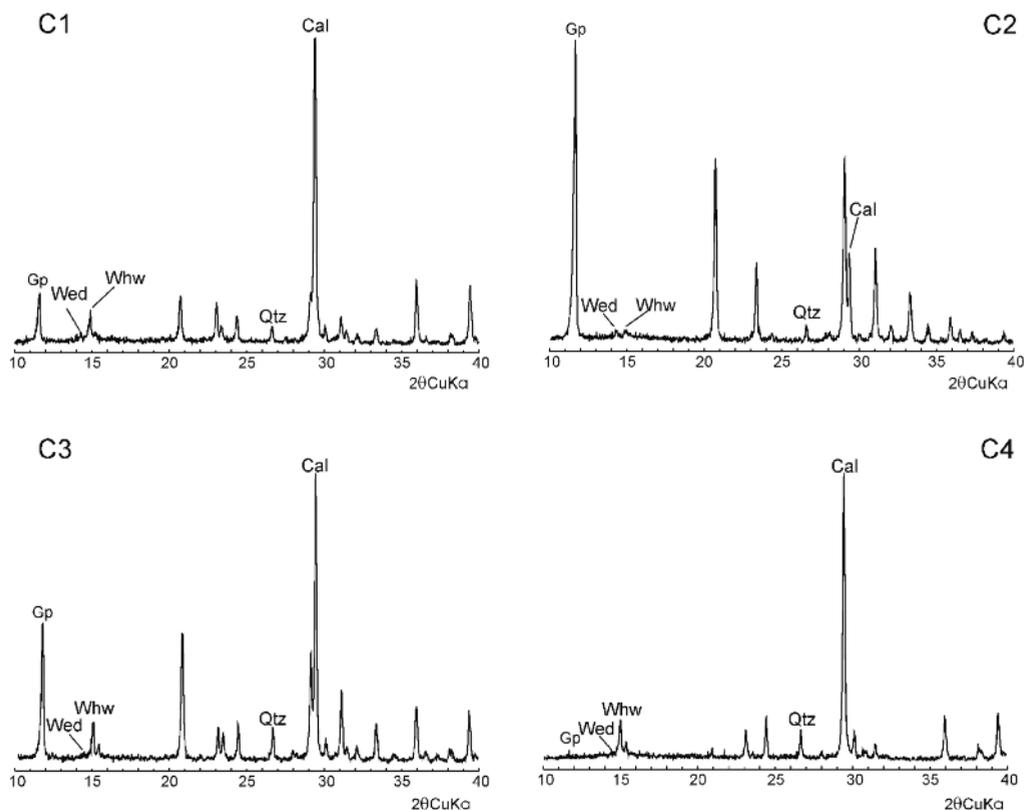
all the investigated samples both whewellite (monohydrated calcium oxalate) and weddellite (bihydrated calcium oxalate) occur. calcite occurs on some portions of the calcareous substratum, gypsum on the black crusts and quartz from solid particles.

Fig. 6 - XRD patterns of the ca-oxalates patinas developed on the surface of the pietra d'istria-orsera c1, c3, of the rosso ammonitico Veronese c2 and of the limestone "facies liburnica" c4. the main peaks corresponding to the identified minerals were labelled as follows. Gp: Gypsum; cal: calcite; Qtz: Quartz; Wed: Weddellite; Whw: Whewellite. Mineral abbreviations are after Kretz (1983) except Weddellite and Whewellite.

are usually bush-hammered and rough, we can exclude hypothesis (iii). since the oxalate patinas usually occur underneath the black crust, their origin by atmospheric particles (ii) is also unlikely. the most likely hypothesis seems to be the one related to a conservation treatment of the stone with organic matter (i), a common practice in the last centuries up to the beginning of the XX century (rossi Manaresi *et al.*, 1989a, b). such organic matter may have then undergone mineralization processes through the action of micro-organisms (cf. Iazzarini and salvadori, 1989). the presence of the oxalate patinas may also be related to the action of micro-organisms such as lichens that are not present now but that may have disappeared due to air pollution. in the case of the Bab agnaou gate in Marrakech, a comparable investigation of decay morphologies has been carried out (Iazzarini *et al.*, 2007). the

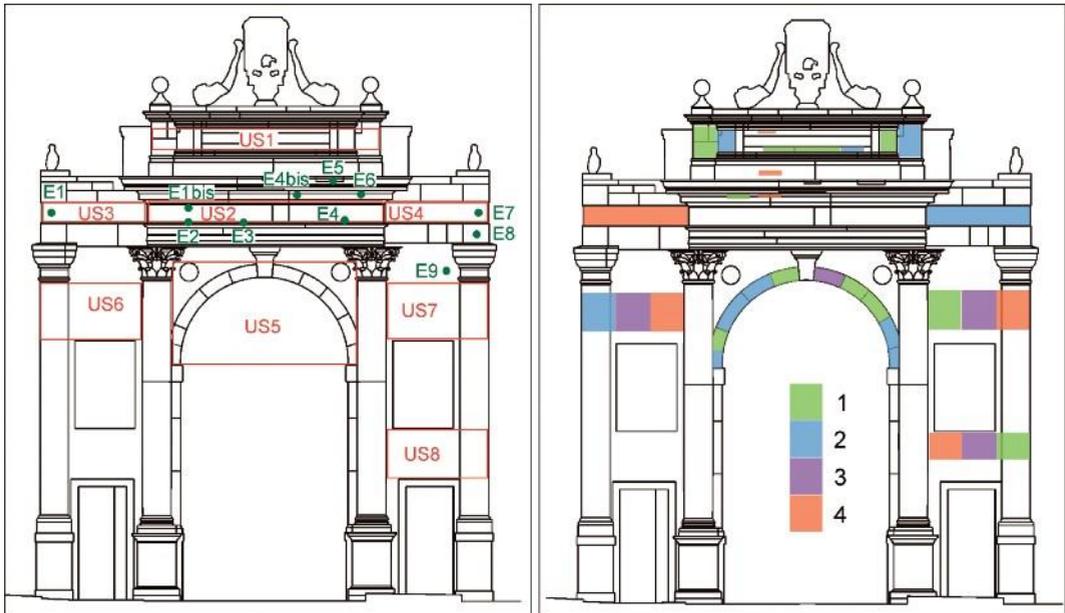
The investigation carried out on porta nuova has not only documented the main deterioration morphologies of ornamental stones, but has also evidenced a severe condition of deterioration of the architectonic structure of the Gate. In particular, the decorative elements at the top of the Gate (court of arms and cornucopias) resulted to be extremely precarious and lacked supporting elements, whereas the lower entablature was severely fissured and bent in the centre.

Gate. in places, apparently without any direct connection, ashlar stones or pieces of walls show deep deterioration with discontinuities and fissurations. in other places, the walls look disconnected (Fig. 7).

Fig. 7 - (a) Location of ashlar stones, dimension stones and hanging walls investigated with ultrasound microseismicity (us1-us8) and point of endoscopic inspections (e1-e9). (b) Results of ultrasound microseismicity: 1 good preservation state; 2 surficial deterioration; 3 surficial to deep deterioration; 4 deep deterioration.

the preliminary intervention presented in this work has been limited to the consolidation and securing of fractured and detached stone elements that not only represent a damage of an historic monument, but may also be dangerous. the intervention is summarized as follows:

- i. removal of weeding and treatment with biocides (benzalconioclorure at 3% and/or neoDesogen and algophase) to inhibit the growing of vegetation and microflora (algae, moss, etc.);
- ii. removal of old detached fillers, which have

been substituted by proper mortars made by Lafarge lime, powder of the same lithotype and a solution of acrylic resins (primal ac 33);

- iii. Maintenance of the still efficient iron clamps by treatment with rust converter followed by iron-micaceous paint. The small cracks due to dilatation around clamps have also been filled with mortars made by lime, marble powder and a solution of acrylic resins. Moreover, the damaged clamps have been replaced by new ones in stainless steel or titanium, which bring as major advantages the minimum thermal dilatation compared to the marble, lightness and minor rigidity compared to iron;

- iv. Micro-injections within stones damage and fractures by epoxy resins (araldite, epoinj) to re-consolidate the latent stone material;
- v. insertion of fibreglass pivots within fracture points of single elements and connection of detached elements to the walls by pivots and clamps and injection of low salinity hydraulic mortars;

- vi. The cracks of the walls were rejoined by employing mortars made by lime and fine to coarse-grained sand;
- vii. consolidation of stone surfaces presenting decohesion and powdering of the material, by ethyl-silicate (estel1000 cts) applied with brush up to saturation.

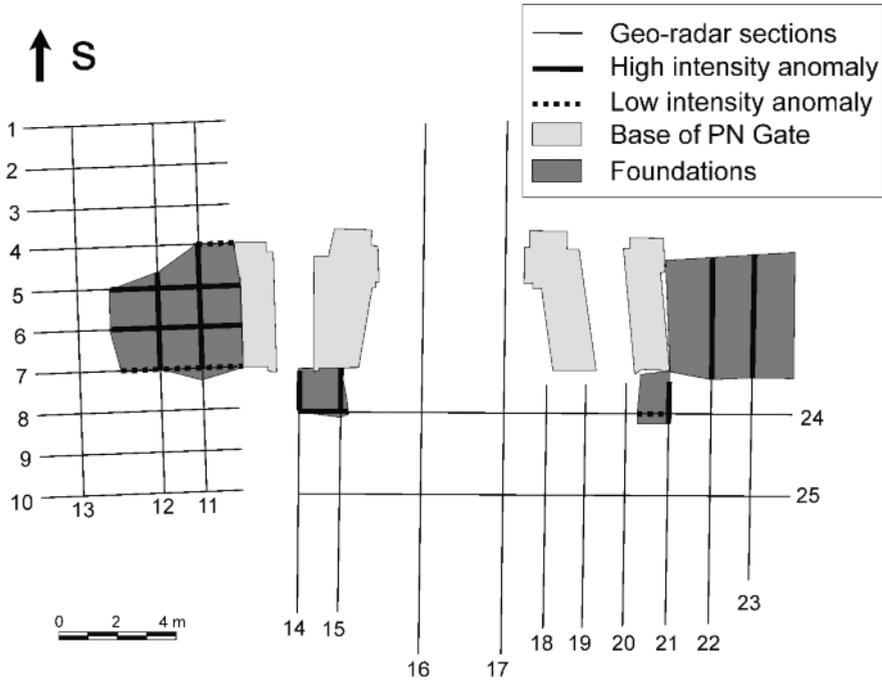
Fig. 8 - Location of georadar sections of the porta nuova area.

the georadar profiles of the first 3-metre underground have shown in detail the good conditions of the foundations and their continuation at both sides of the Gate (Fig. 8).
