Experimental Techniques for Mechanical Properties of Geopolymer Coatings, Corrosion Protection of Steel

ABSTRACT

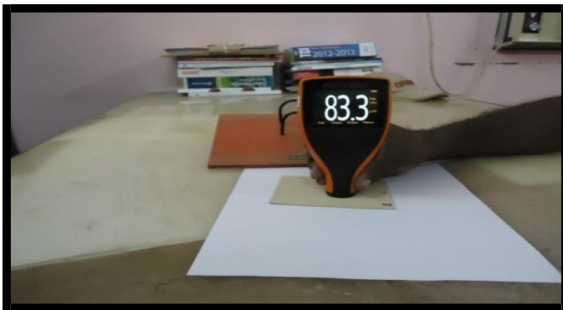
Fig. 2: Measuring coating thickness

A. Estimation of the thickness of the coating: The thickness of the coating on the lined plate became measured as proven in Fig.2. with the aid of using Elcometer, Great Britain. The Elcometer device was saved perpendicular to the lined plate While the measuring was carried out. The dried movie thickness of the coating became measured at numerous locations on the

The thickness of the coating can become measured, with the use of a reachable virtual show thickness measuring tool as implied. Upon every covered floor, 6 to eight measurements are averaged, and the common values have been lied in among 210 to 237micrometeres.This coating thickness is called the dry film thickness (dft).

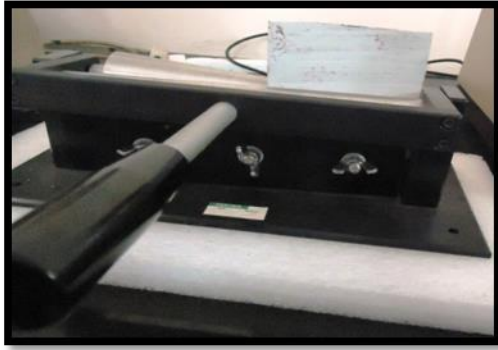
Fig. 4: Conical Mandrel Apparatus

The Bend ability take a look at turning into performed through a conical mandrel bend, take a look at the equipment as consistent with ASTM D522 standards. The tool was turned into bought from M/S Sheen devices Ltd., Richmond, and Survey, England. The skinny plate of 100mm x 150mm x0.8mm turned into used to inside take a look at. Fig. 4. illustrates the shape of mandrel conical equipment, one quit of the equipment is 3mm diameter which progressively will increase as much as 38mm diameter with the quit of the length (200mm). The plates had been constant inside conical mandrel bend equipment, and tighten the wing nuts with the use of a rolled handle. The skinny plate turned into bent as much as 180o in an unmarried step. Cracks had been located from 3mm diameter in the direction of better quit of the plate. The wing nuts had been loosened to take out the bent plate. The bent plates had been proven in Fig. 5. The cracks, if any, had been measured and the outcomes had been proven in Table.3.

The flexibility of covered plate becomes located with the aid of using conical mandrel, take a look at wherein a covered plate becomes rolled to conical form with an assist of a deal and cone as proven. The coatings have been located with to none signal of cracks at the conical floor and have been taken into consideration as "handed". If the cracks are located along the covering of the fold, they have been distinctive as "bankruptcy". This take look at has been executed for all twenty specimens and the effects have been pronounced in desk 3. The coatings GP7, GP13, and GP16 have been failed on this conical flexibility take a look at. The compositions of these types of 3 coatings have been silicate wealthy coatings and the most effective Al_2O_3 became delivered. The silicate richness of the composition provided a rigid geopolymer formation. So these 3 coatings failed in flexibility, take a look.

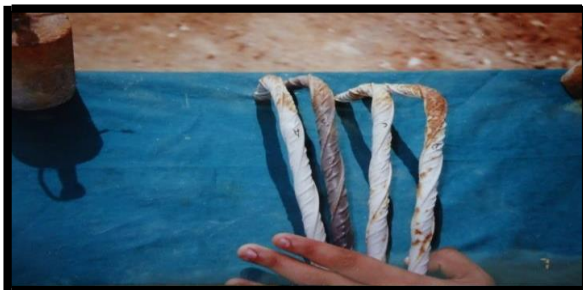
Fig. 6: Bended rods

D. Bendability Test on Rods (IS 1599:1985): After pretreatment in triplicate, immediately deformed cold twisted bars of 8 mm, 10 mm, 12 mm, and 16 mm in diameter were coated. These bars were subjected to a bending check with a mandrel. The pin is changed to regular with clean plastic sheets at the guide so that when bending operation no damage was modified induced to the coating through the manner of approach of the mandrel. Immediately the coated bars are bent at 45° and 90° from its precise immediate line. During and after the bending operation, the covered ground on the metallic bar is modified into deciding for the development of cracks, fissures, disbandment, straining, domination, discoloration etc. Fig.6. indicates the bent rods. Observed effects have been reported for selected coatings in Table 4.

Coated rods have been having 4, one -of-a--a-kind diameters together with 8, 10, 12, and 16mm which have been subjected to bending, take a look at as much as 450 and 900. After the bent, every covered floor can become tested with magnifying glass for any formation of cracks, fissures, delimitation, and discolourization because of strain awareness to the bent. If one of the identified defects is classified as defect (F), in any other case, it exceeds (P). 8mm and 10mm rods have been handed out with the studied coatings, however for 12 and 16mm failed in GP13. From all above take a look at the effects the coatings, GP10, GP11, GP12, GP14 & GP15 carry higher in anything you recognize with mechanical strength and corrosion.

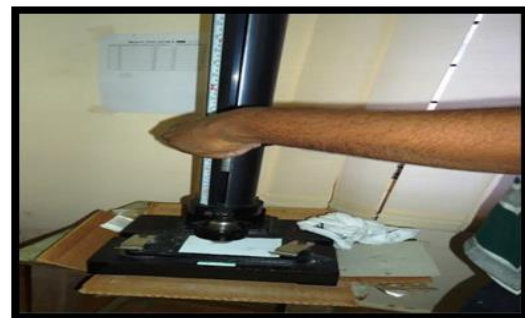
Fig. 7: Impact Test apparatus

E. Impact takes have observed plate (ASTM D 2794): The impact takes have a take a observe modified to completed as consistent with ASTM D 2794 standards. A thin plate of the period 100mm x150mm x0.8mm becomes modified to apply for the take a look. The plate was modified into place at the bottom of the gadget which was modified into demonstrated in Fig.7. And the outcomes taken as a take a observe on the plates were demonstrated in Fig.8. A piston of mass 2 lb (or) 8.89 N was modified to freely bring to the plate from a pinnacle of 30cm and 60 cm. The two edges of the slabs were subjected to shock, and the capacity of resistance to direct and indirect shocks of the coating was rewarded. The effects are shown in Table 3.

D14. This has been illustrated in Figs 6 & 7 on effect of the metallic ball on the covered plate floor will depart the mark of dispersion after the effect. The impacted plate could be tested and the opposite aspect with the assist of magnifying glass for the formation of cracks, fissures, and delimitation. If each plate and covered rods do now no longer exhibit defects, then they have been rated as handed and the defected coatings have been marked as failed. The effects have been given in Table 3.
