SEM-XRD investigation of deterioration morphologies and consolidation prior to restoration: the case of Porta Nuova in Ravenna (Italy)

Key Words: *Deterioration, SEM-EDS and XRD, consolidation and securing, Porta Nuova.*

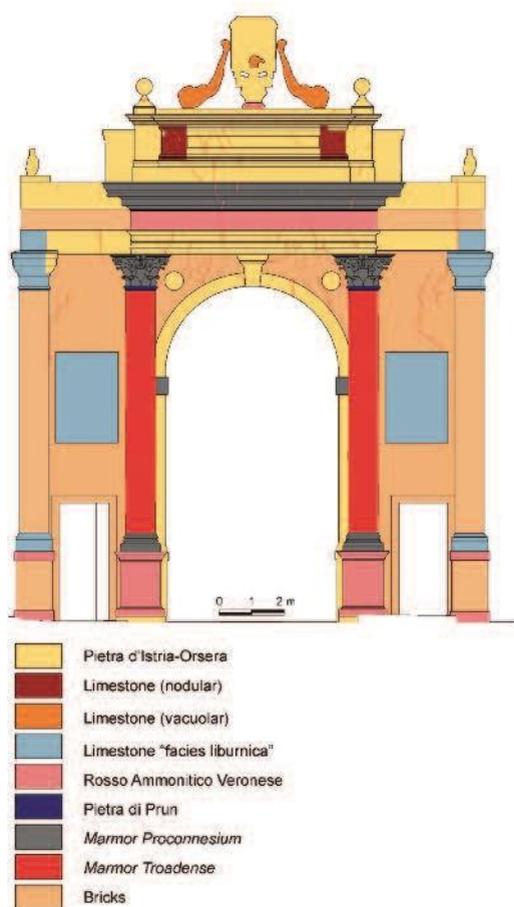
Results of a recent work (Marocchi *et al.*, 2009) indicate the presence of different ornamental stones. The widespread material is the pietra d'Istria Orsera. Also important was the use of the "marble" Rosso Ammonitico Veronese. Valuable architectural components such as the composite capitals and the columns drums are carved in *Marmor Proconnesium* (island of Marmaraturkey) and *Marmor Troadense* (Çiğri Dâg, NW Turkey) respectively. Peculiar is also the use of the pietra di prun (Verona), trachite dei Colli Euganei (Padua) and limestones of Istrian or Venetian provenance ("vacuolar", "nodular" and "facies liburnica") (Fig. 1).

Fig. 1 - schematic sketch of porta nuova front with the classification of the ornamental stones (modified after Marocchi *et al.*, 2009).
